ECO METAL RECYCLING INC.
35 PINELANDS AVENUE,
STONEY CREEK, ONTARIO
L8E 3A6

DECEMBER 7, 2023

**RE: INVESTIGATION AND VERIFICATION SOIL SAMPLING FOLLOWING AN
UNDERGROUND STORAGE TANK REMOVAL – ██████████
██████████ ONTARIO**

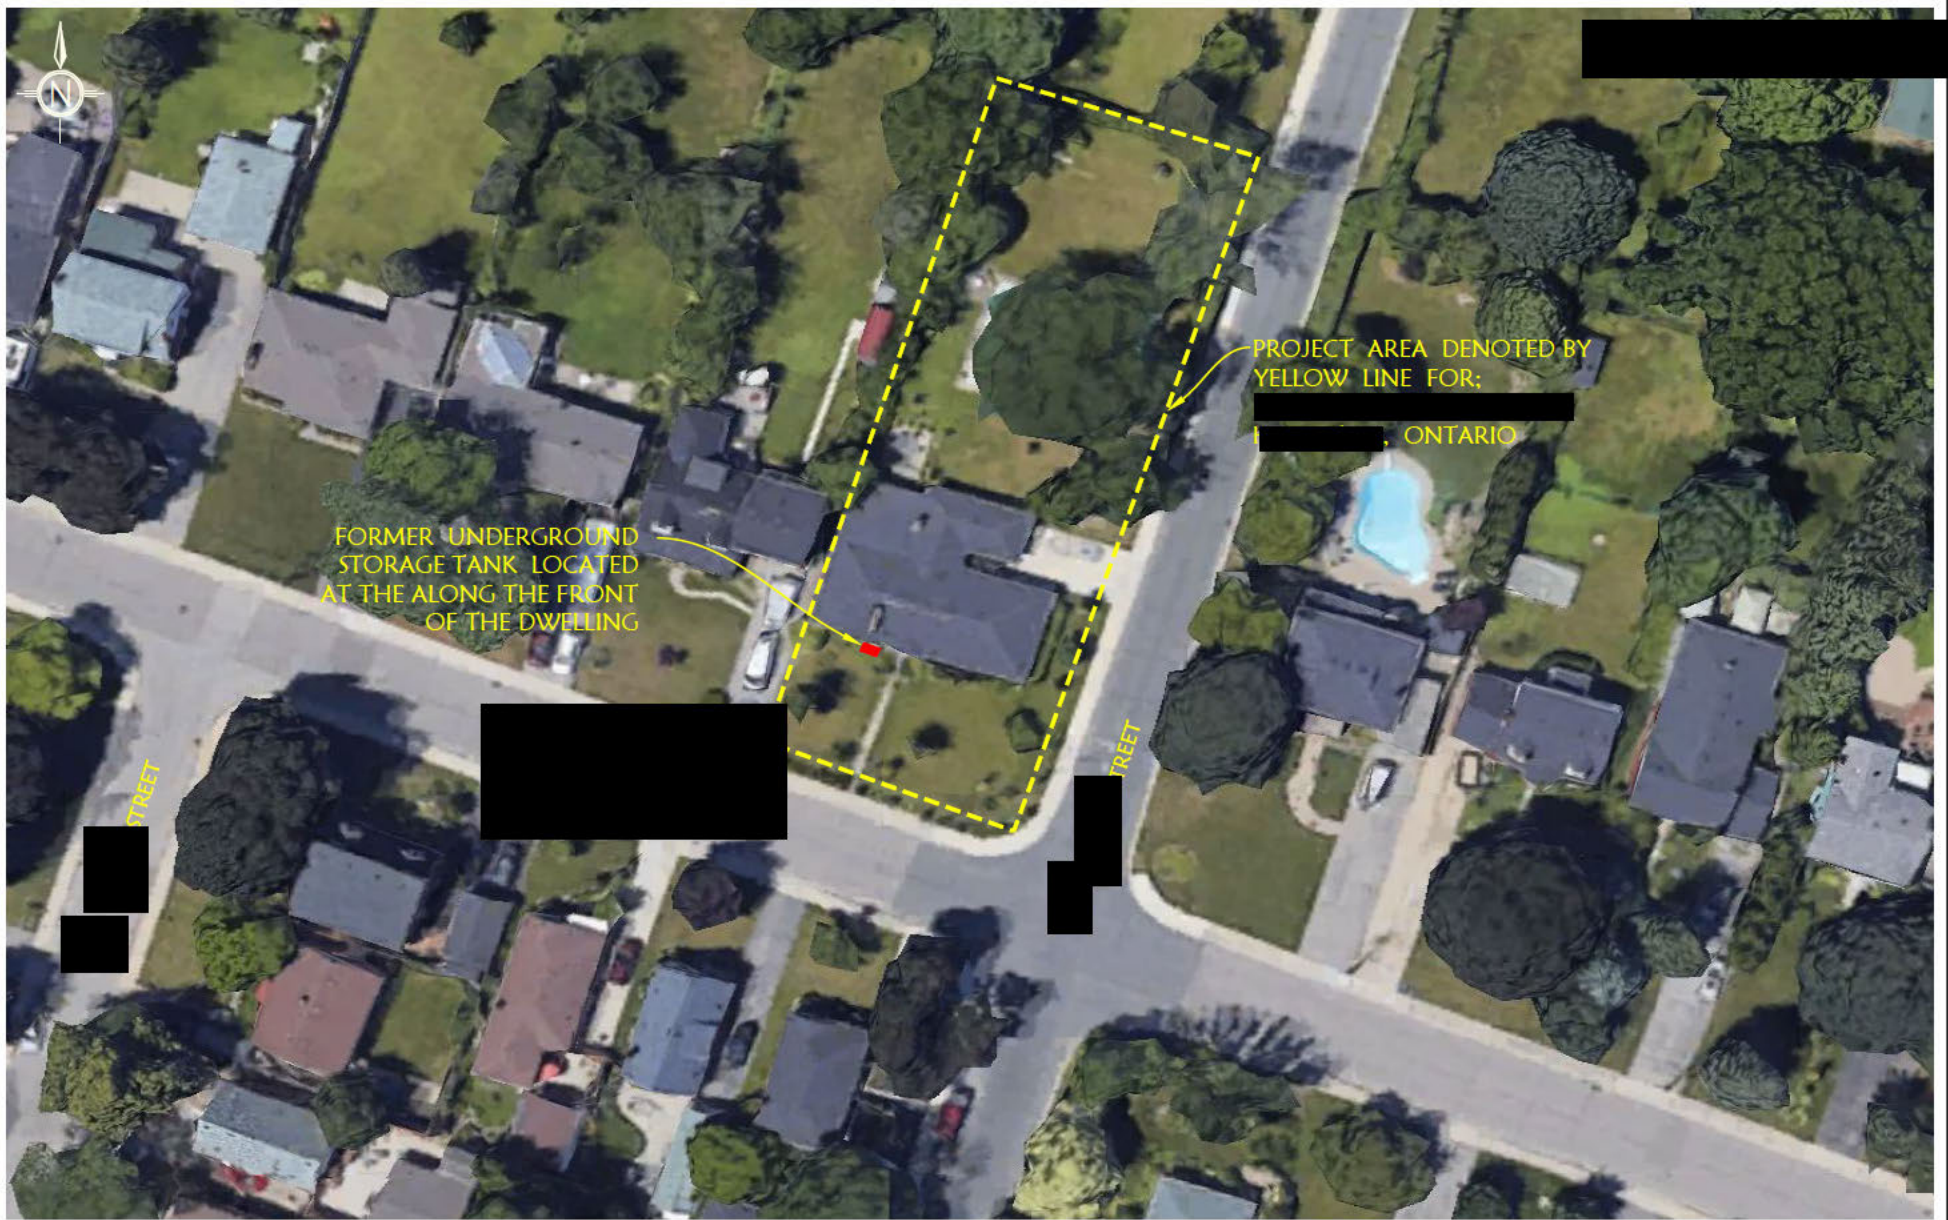
The subject site is a residential property located in ██████████, Ontario. Occupying the property is a single storey white brick dwelling. The UFST is located running parallel with front exterior wall of the dwelling and against the concrete front step on the site. Bordering the site to the north are residential properties, south is ██████████ ██████████ are more residential properties. Refer to Figure 1 for an aerial view of the site.

The UFST was exposed by Danosh using a rubber tracked excavator. The tank was found to be of steel construction and typically for interior use. Upon discovery, the tank was buried along the south exterior wall of the dwelling and found to be empty. The tank was approximately four inches below the surface and the base of the tank resting directly on bedrock. (Ref. Figure 1).

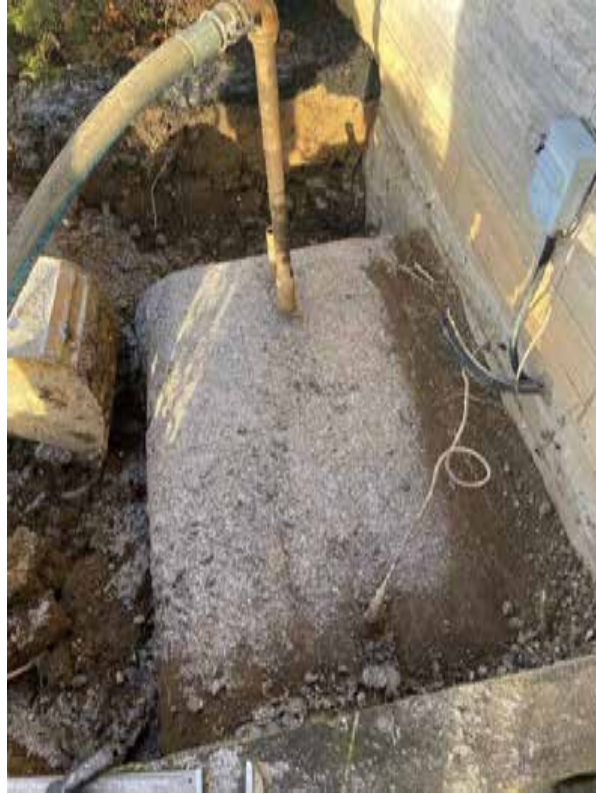
PHOTO 1 – NORTHWEST FACING VIEW OF THE TANK NEST PRIOR TO TANK REMOVAL.

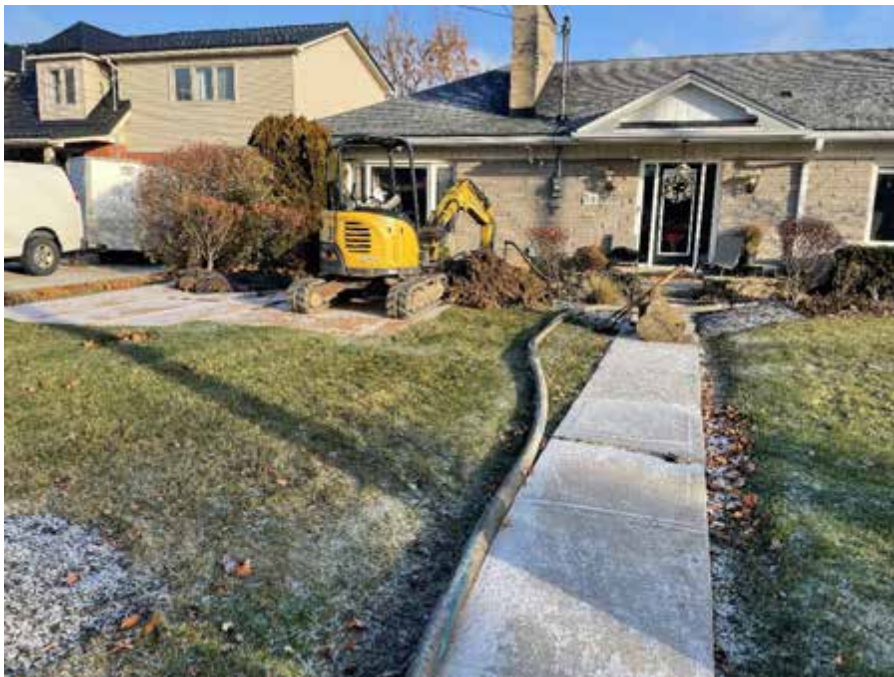
PHOTO 2 – NORTH FACING VIEW DURING EXCAVATING.

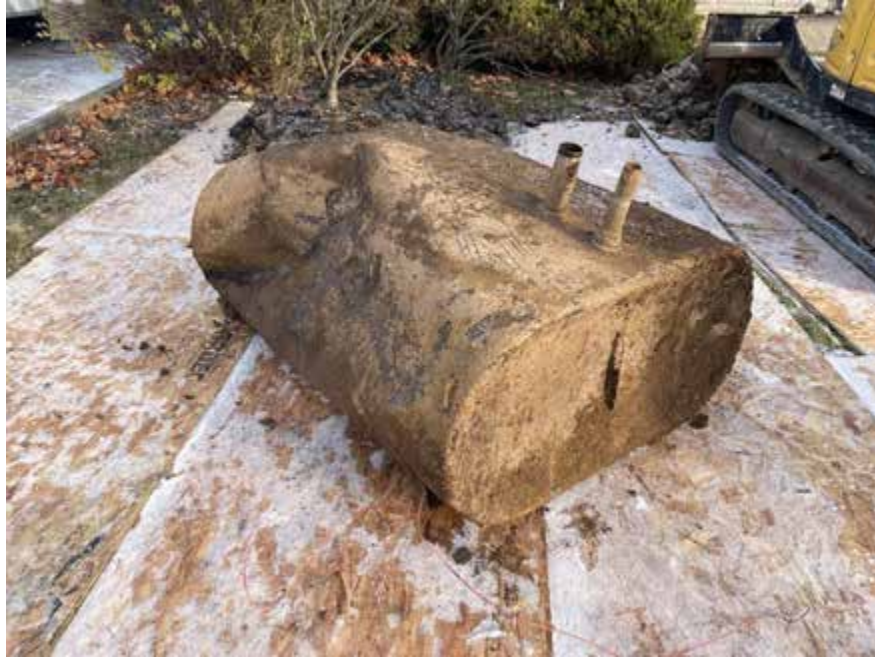
Following the removal of the tank, a visual inspection conducted and identified no noticeable damage. The capacity of the UFST was approximately 900 L. An inspection conducted of the former tank bed identified no areas of concern through visual and olfactory observations of possible petroleum hydrocarbon contamination (PHC).

PHOTO 3 – VIEW OF THE REMOVED STEEL TANK.

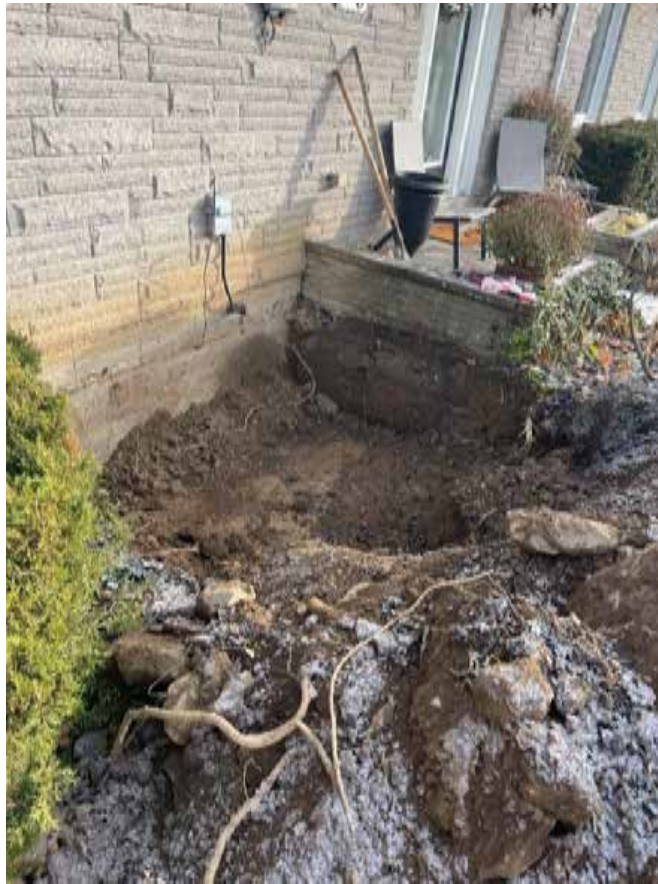
PHOTO 4 – NORTHEAST VIEW EXCAVATION AFTER TANK REMOVAL.

There are no further remedial activities recommended at this time.
